# Investigation of Keeper Erosion in the NSTAR Ion Thruster

Matthew T. Domonkos  
Glenn Research Center, Cleveland, Ohio

Prepared for the  
27th International Electric Propulsion Conference  
cosponsored by the AFRL, CNES, ERPS, GRC, JPL, MSFC, and NASA  
Pasadena, California, October 14–19, 2001

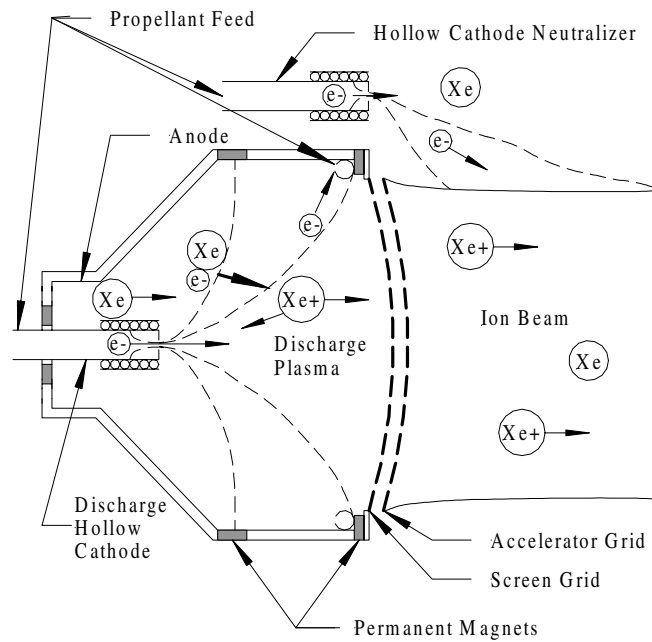
**Figure 1 – Schematic of a ring-cusp ion engine.  
Keeper electrode not shown. Drawing not to scale.**

The NSTAR ion engine is a ring-cusp design, as shown in Figure 1. The discharge hollow cathode creates an internal plasma which enables emission of an electron current in excess of space charge limitations. A magnetic circuit is created within the ion thruster using permanent magnets in a ring-cusp configuration, and the electrons emitted by the hollow cathode stream toward the anode along the magnetic field lines. Neutral xenon is also injected directly into the discharge chamber. Collisions between the electrons and neutrals create the ions in the discharge chamber. The magnetic circuit also acts to control the effective anode area and to contain the high-energy electrons for ionization while thermalized low temperature (a few eV) electrons conduct the current to the anode [7]. The ions are focused and accelerated by the grids, while the electrons are contained within the discharge chamber. The discharge hollow cathode is operated at relatively high-current to generate sufficient ions to sustain the beam current. Under ideal conditions, the bulk of the discharge can be thought of as quasineutral plasma consisting of various ion species, and primary and Maxwellian electrons. The steady-state potential in the quasineutral plasma has been measured to be 4 to 7-V above the anode [8]. Sheath regions bring the local space charge from plasma potential to the respective electrode potentials. Consequently the energy of ions which strike the keeper is expected to be the product of their charge state and the difference between the bulk plasma and keeper potentials.

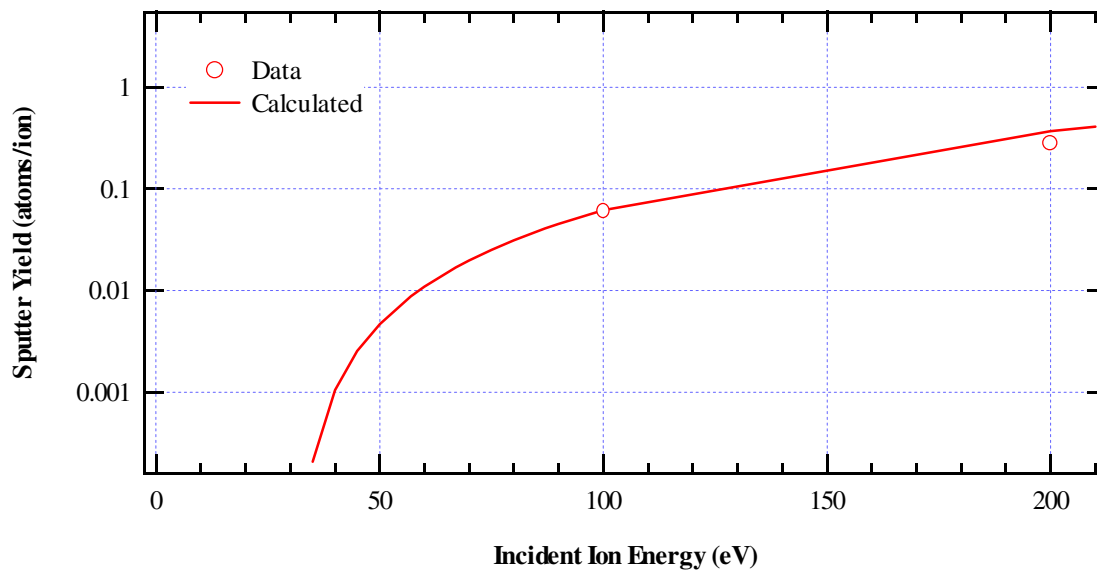
**Figure 2 – Experimental and calculated values of the low energy sputter yield of xenon on molybdenum [9,12].**

Equation 1 will be used in the present investigation, and the dependency of molybdenum sputtering due to xenon is plotted in Figure 3. Small changes in discharge voltage or surface potential within the discharge chamber translate to large relative changes in the sputter yield. Consequently, sputtering of discharge chamber components is expected to scale strongly with discharge voltage and the potential of the component. Additionally, the sputter yield predicted by Equation 1 is assumed to be independent of the ion charge state.

Singly charged ions incident at large angles will sputter surfaces at energies below that depicted in Figure 3 [13]. Williams [15] measured singly charged ions flowing toward the discharge cathode keeper at large angles outside of the sheath. Nevertheless, erosion by single ions incident at large angles is expected to contribute weakly to the overall sputter rate since the fall voltage will provide most of the ion velocity, yielding near normal incidence.

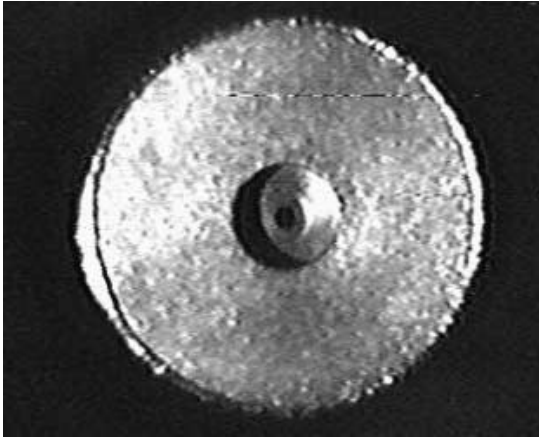
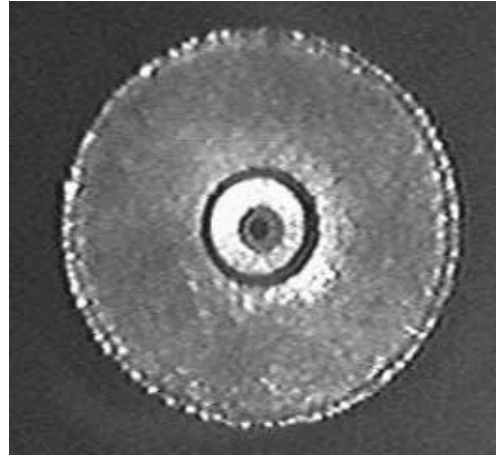
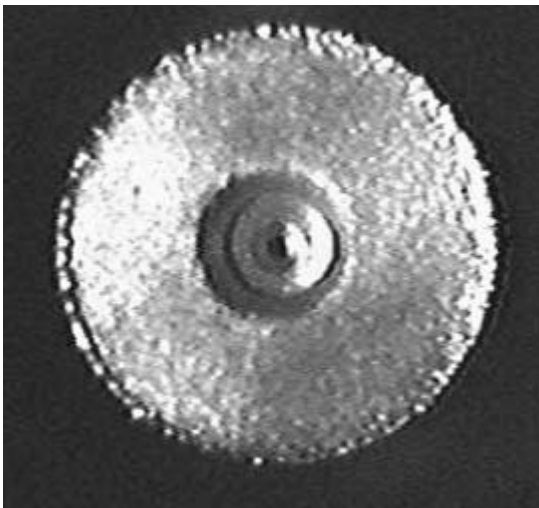
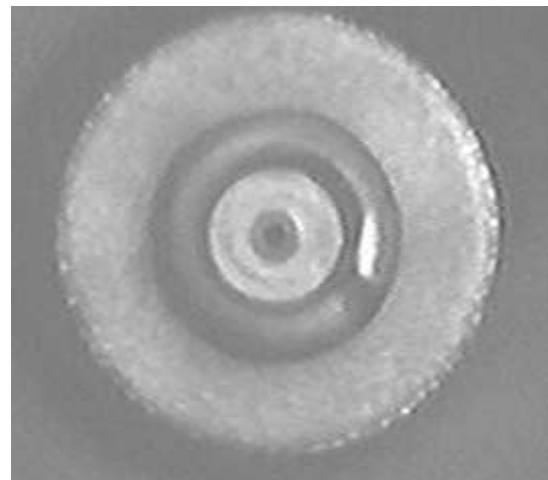
a) 447 hours

b) 4,693 hours

c) 6,408 hours

d) 12,342 hours

**Figure 3 – Evolution of the FT2 discharge cathode keeper erosion. Courtesy JPL.**

Photographs taken outside of the vacuum facility of the discharge cathode keeper on FT2 are shown in Figure 3. Photographs and data from the ELT were furnished courtesy of JPL. For reference purposes, the keeper orifice plate diameter is 1.91-cm. After 447 hours the keeper showed negligible wear. By 4,693 hours, a small chamfer was evident on the keeper orifice. The observed erosion accelerated between 4,693 and 6,408 hours as shown in Figure 3c. The rate of increase in the keeper orifice diameter appeared to be approximately constant through 12,342 hours. Since the ELT is ongoing, the photographs in Figure 3 constitute the best measurement of the keeper erosion currently available. Although post-test analysis will enable greater examination of the keeper, this investigation was limited to the information contained within the photographs.

total volume lost from the keeper face in the 8,200 hour test and the estimated ELT erosion based on the images in Figure 3 and the assumed geometries of Figure 7. The estimated range of volumetric erosion reported in Figures 16 and 17 was calculated by fitting the discrete values with a polynomial to yield a smoothly varying distribution. The volumetric erosion observed during the ELT appears to be consistent with the previous tests, although the evolution was clearly different. The estimated volume of molybdenum removed from the ELT discharge keeper ranged from 128 to 238-mm<sup>3</sup> in the first 12,342-hours.

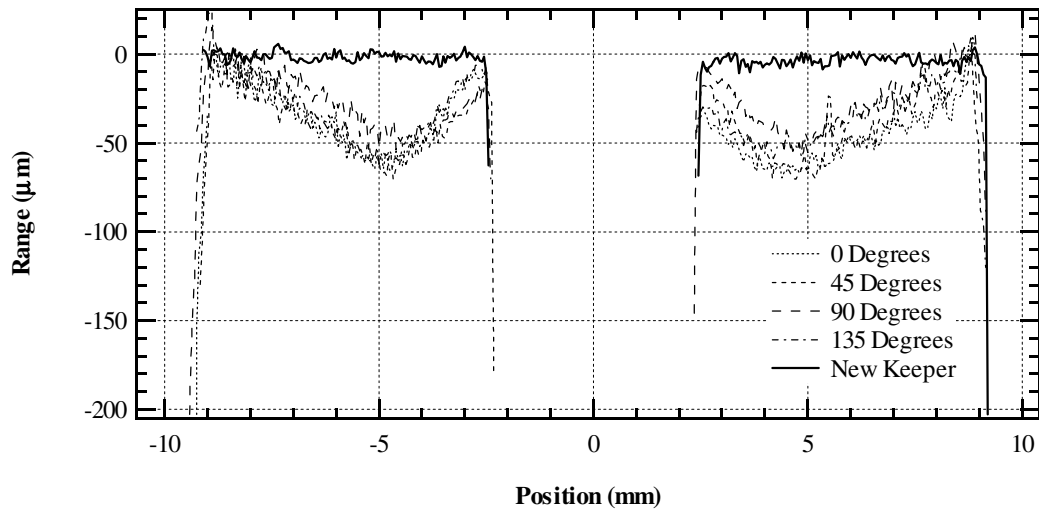
**Figure 4 – Downstream erosion of the discharge cathode keeper for the 1,000 hour wear test on several diameters indicated by their angle relative to an arbitrary zero degree diameter.**

from the NSTAR throttling table are reproduced in Table 1 for convenience [3]. The keeper potential averaged 4.6-V  $\pm$  0.1-V above cathode and drew approximately 20-mA of current [6]. Figure 4 shows four profiles of the downstream face of the discharge cathode keeper from the 1,000-hour wear test. Since the initial condition of the keeper face was not measured, the profile of a new keeper fabricated to the same specifications was used as a reference. In the profiles, the outer edge of the keeper was assumed to be the reference point. The comparison, shown in Figure 4, indicates that the erosion was greatest at a radius of 5-mm without an observable chamfer on the orifice. The maximum wear rate observed in the 1000-hr test discharge keeper was approximately 70- $\mu$ m/khr. Post-test destructive analysis from the 8,200-hour wear test also shows moderate discharge cathode keeper erosion with a pattern similar to that of the 1,000-hour test keeper [4]. The 8,200-hour wear test was also conducted primarily at the maximum throttle condition (TH15) [4]. Although the orifice exhibited significant erosion, the maximum wear rate was observed on the downstream face, similar to the erosion of the 1,000-hour test. The maximum wear rate was approximately 64- $\mu$ m/khr at a radius of 5.3-mm. Since the two wear tests conducted with a discharge cathode keeper exhibited similar and modest wear, both the Flight Thruster 1 (FT1) on Deep Space One and FT2 were expected to erode at the same rate and pattern observed in the previous wear tests.

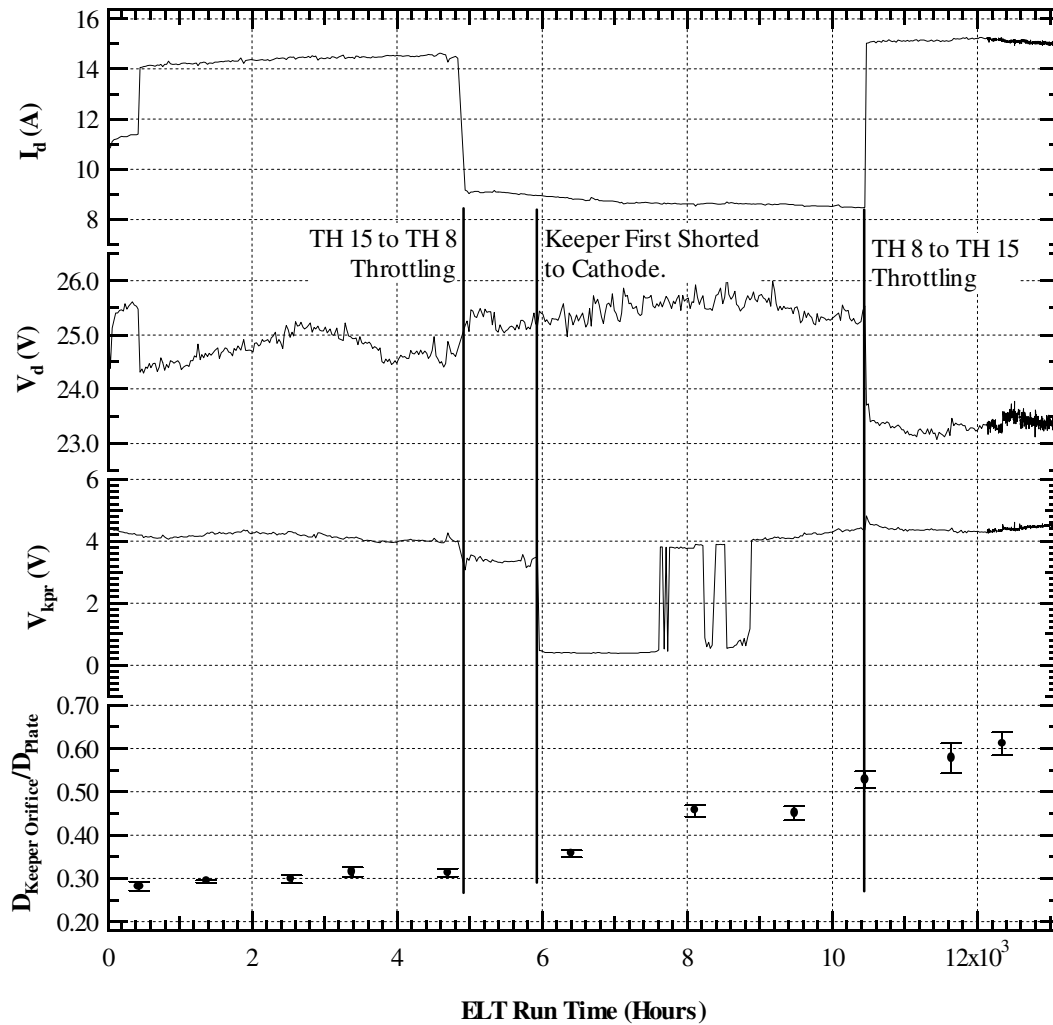
**Figure 5 – Discharge parameter history of the ELT with an estimate of the erosion. Courtesy JPL.**

The test conditions during the ELT differed from the previous wear tests, and thruster discharge current, discharge voltage, and keeper potential are presented in Figure 5. At approximately 450 hours, the thruster was set to TH15 where it operated until 4,835 hours run time. Between 4,835 and 10,445 hours, the thruster was operated at TH8. The thruster was then throttled to TH15. Prior to the ELT, TH15 was thought to be the most demanding condition in terms of component wear. Since the ion flux to surfaces is a function of discharge current, TH15 with the highest discharge current was expected to represent the harshest operating condition. The erosion was observed to increase only after an extended duration at TH8. The estimated keeper orifice diameter, normalized to the keeper outer diameter, is also presented in Figure 5. The orifice diameter was estimated from the images provided by JPL.

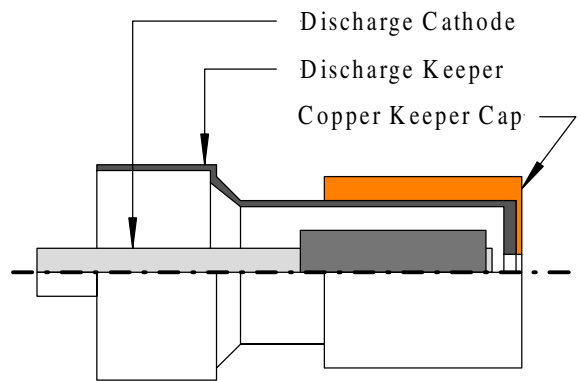
**Figure 6 – Discharge keeper with copper cap. Drawing not to scale.**

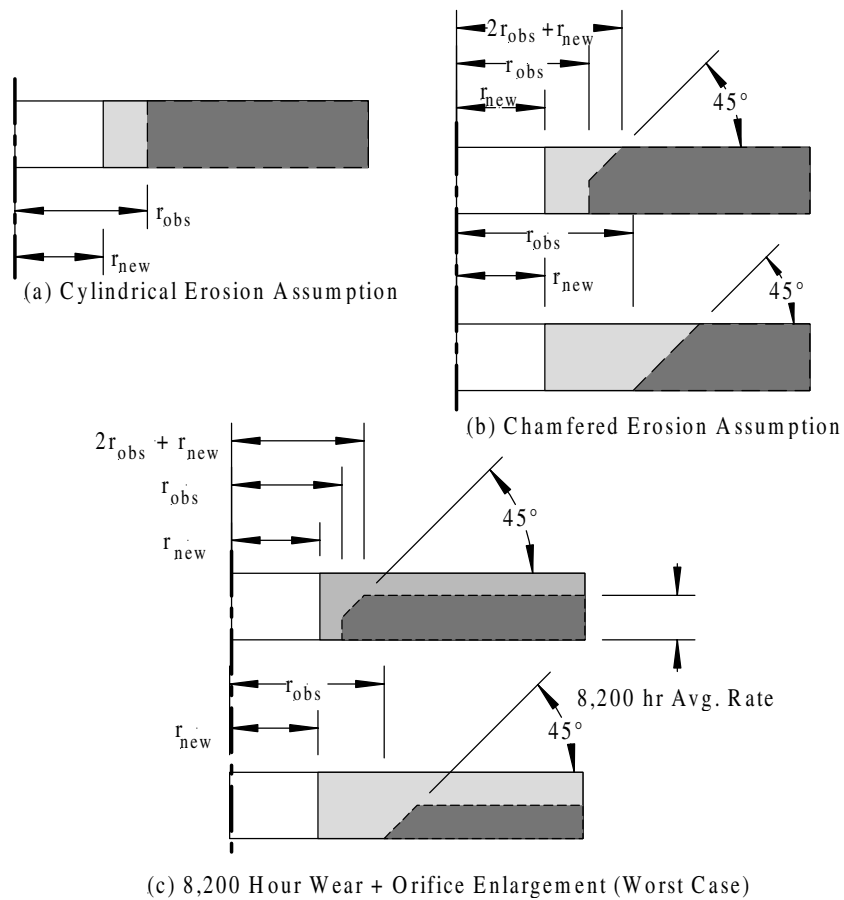
**Figure 7 – Illustration of the assumed erosion geometries providing bounds for the estimated erosion volume of the ELT keeper.**

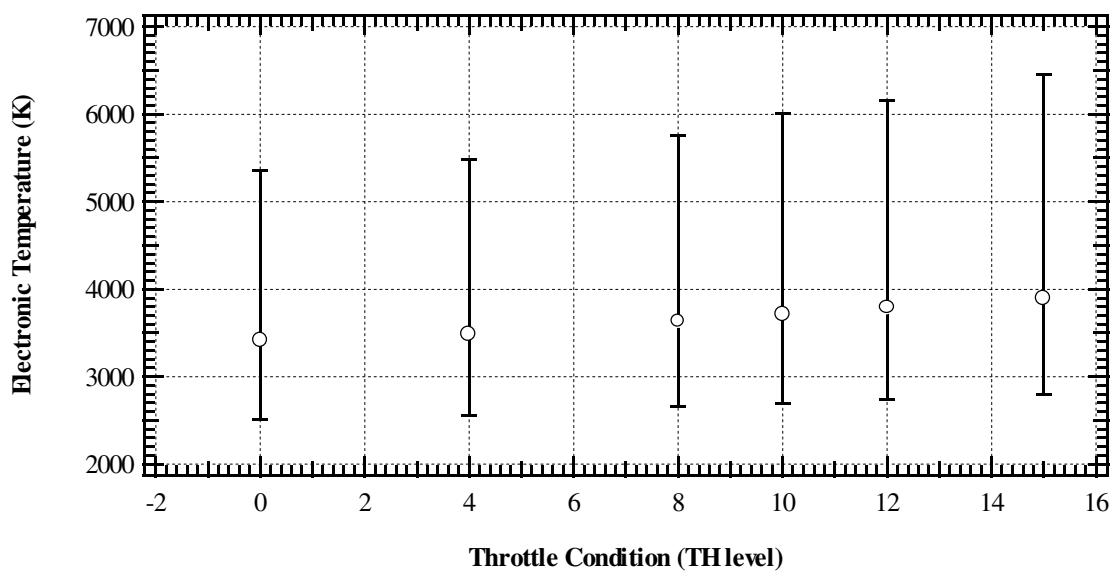
Figure 8 – Dependence of the electronic temperature measured using XeI in the discharge chamber as a function of throttling condition.

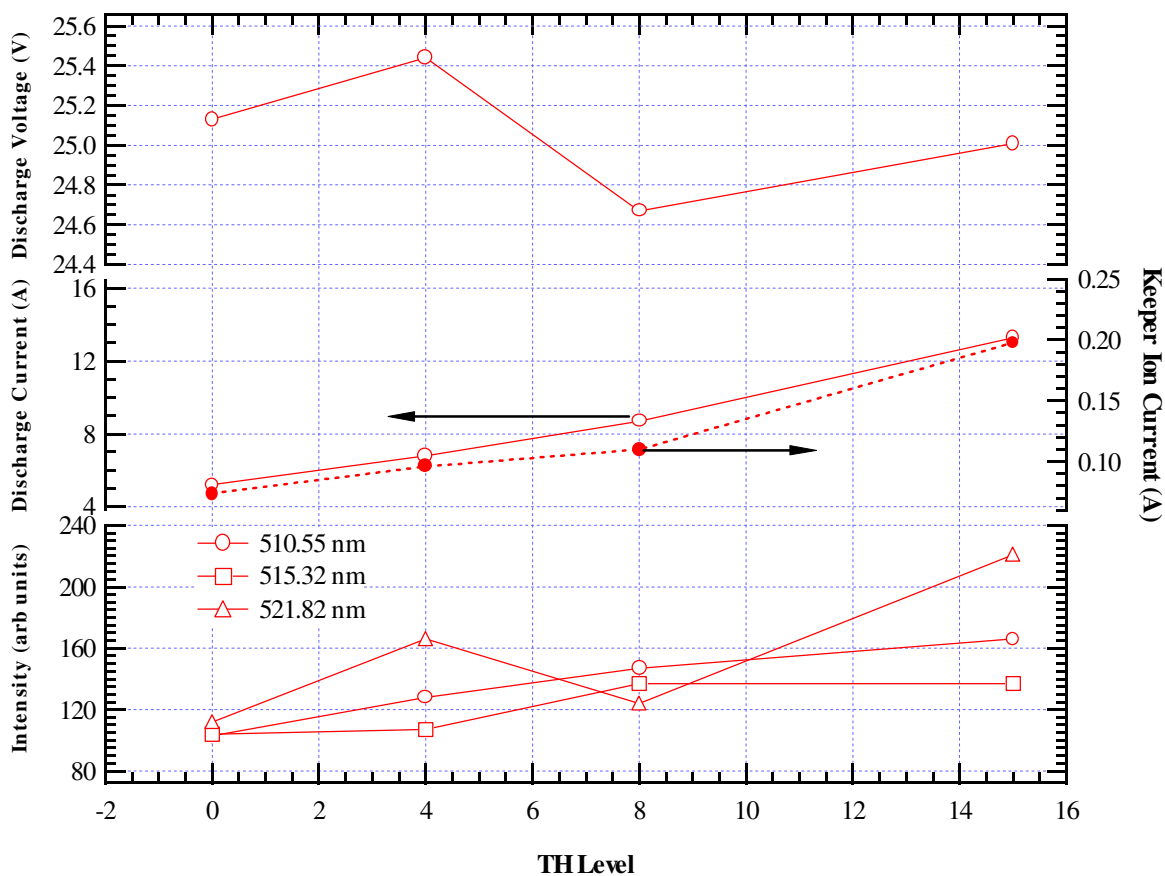
Figure 9 – The dependence of emission intensities on discharge conditions.

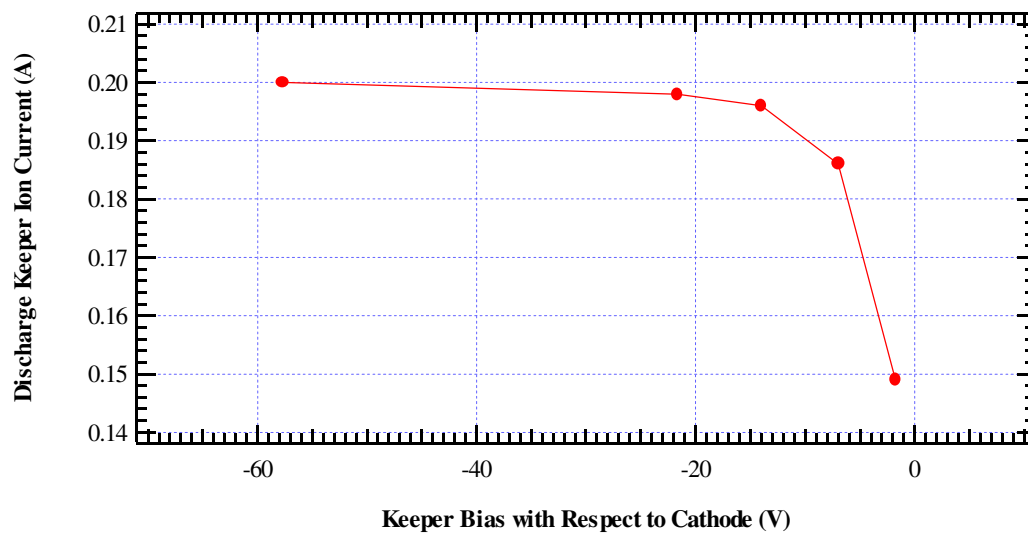
Figure 10 – Keeper saturation current at TH15.

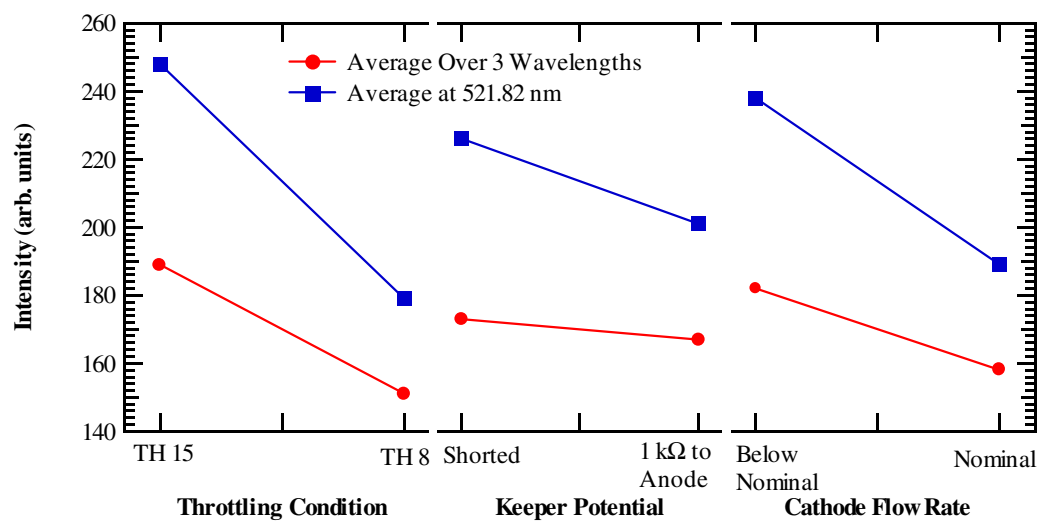
Figure 11 – Pareto chart illustrating the relative sensitivity of the copper emission spectra to extremes in discharge conditions.

The relative sensitivity of keeper erosion to throttling condition, keeper potential, and discharge voltage oscillations is plotted in Figure 11. Lowering the cathode flow rate increased the discharge voltage oscillations from 5 to 10-V peak-to-peak. The slope of each line is indicative of the relative importance of that parameter, over its predetermined range, to the emission signal and, by extension, the erosion rate. The throttling condition sensitivity is plotted with the caveat that it is dependent upon electron temperature and number density. Nevertheless, the copper spectra indicated that the erosion rate was most sensitive to the throttling condition. The sensitivities to keeper potential and discharge

oscillations are presented since they sample from each throttling condition equally and are therefore independent of the plasma conditions at TH8 and TH15. From this, the discharge oscillations contribute to erosion somewhat more than the keeper potential. This is consistent with the fact that the oscillations were of the order of 10-V (high-wear condition) and 5-V (low-wear condition) peak-to-peak which leads to a slightly larger accelerating potential for ions than the keeper short (~3 to 3.5-V). The analysis showed also that the interactions of parameters are insignificant.

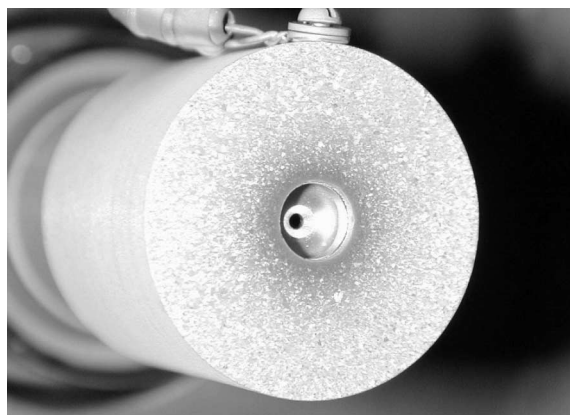
Figure 12 – Post-test visual inspection of the copper keeper cap.

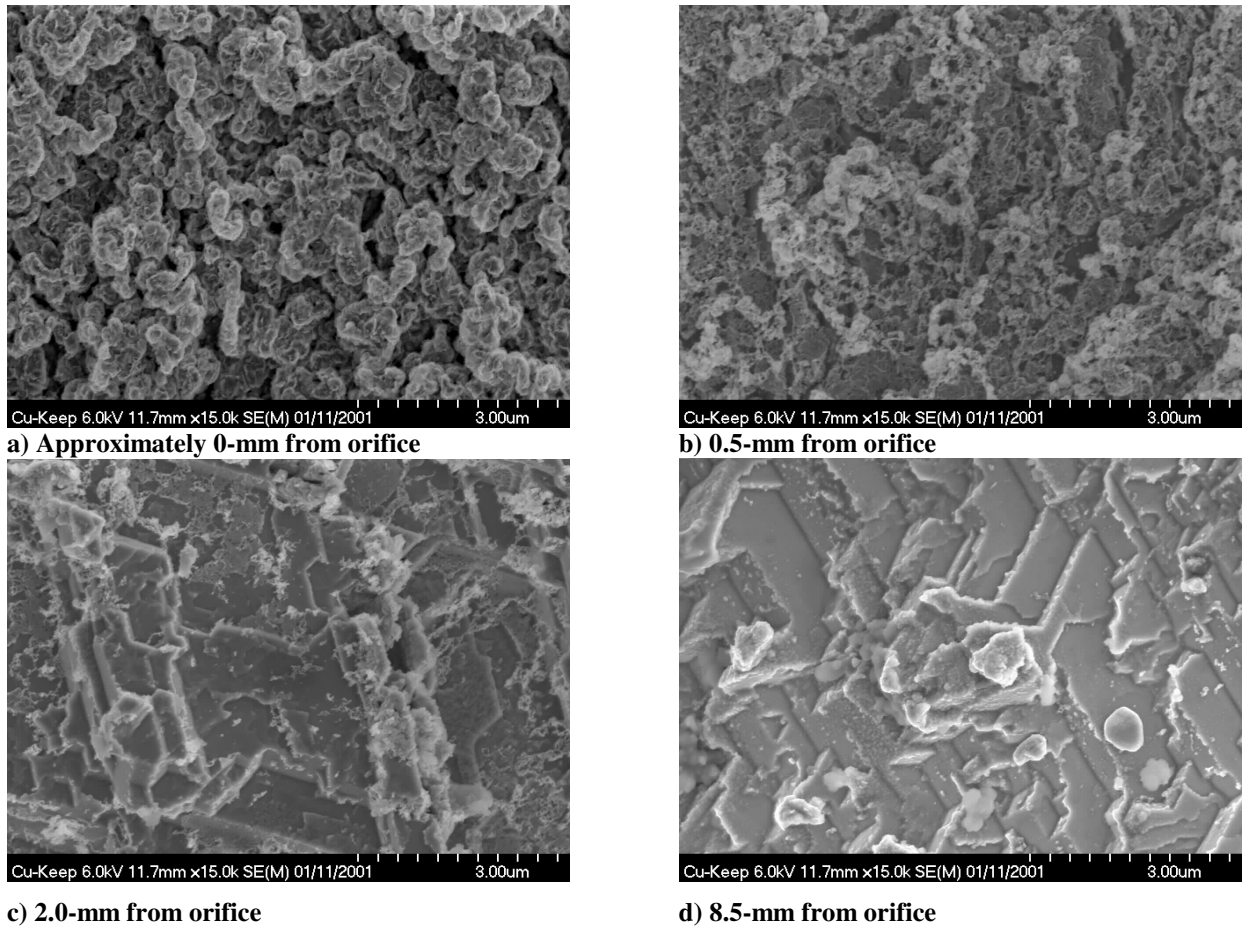
Figure 13 – SEM photomicrographs of the copper keeper face at several radii.

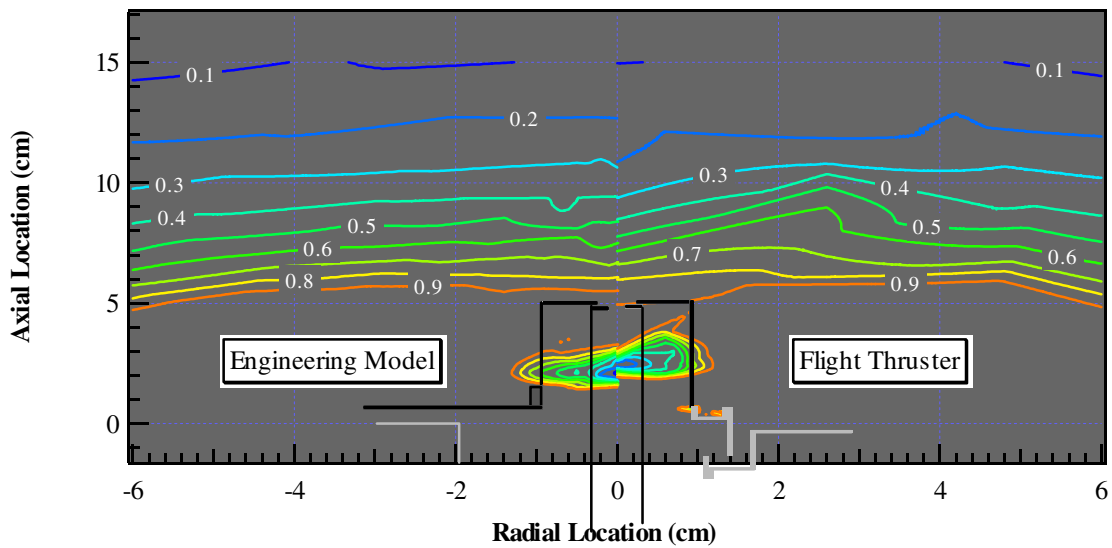
Figure 14 – Axisymmetric normalized magnetic flux density contours in the near keeper region for the engineering model and flight thrusters. Light gray components are made of nickel-steel.

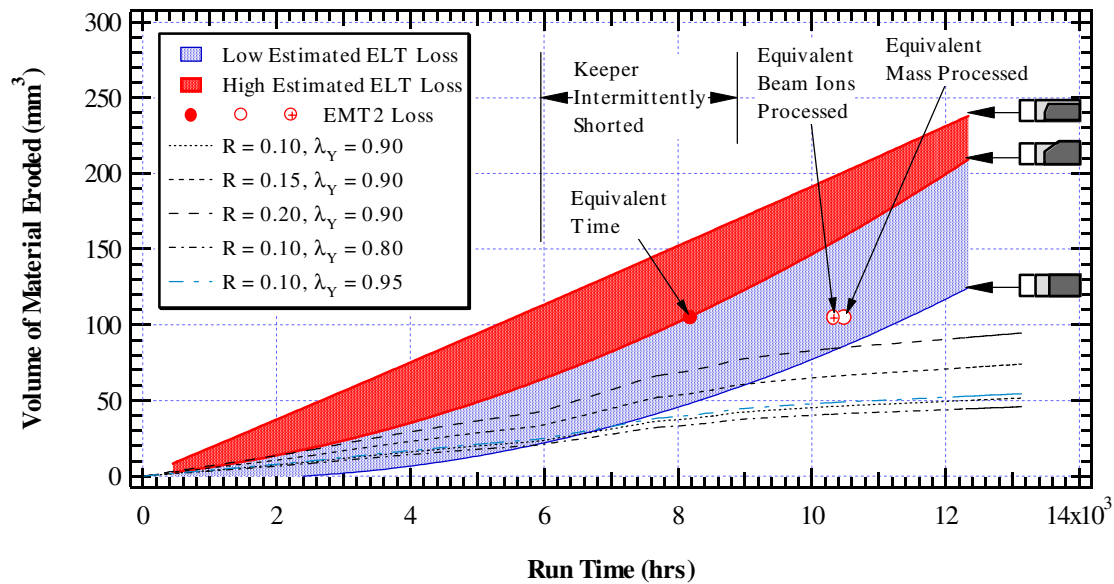
Figure 15 – Observed and calculated eroded volume of the ELT discharge cathode keeper. Only doubly charged ions with negligible temperature and created at a plasma potential equal to anode are assumed to sputter the keeper.

The calculated erosion based on the assumption that the plasma potential is equal to the anode potential underestimates the observed wear. Conversely, assuming the plasma potential to be 4-V greater than the anode results in estimates comparable to or greater than the observed erosion. In both cases, the greatest erosion rate was calculated when the keeper was near cathode potential, although the TH15 erosion rate with the positive plasma potential was comparable. The results also illustrate the importance of quantification of the ratio of double-to-single ion current to the cathode; the calculated erosion varied by as much as a factor of 2 depending on the assumed double-to-single ion current ratio and yield factor. Diagnostics to measure the content of the ion flux to the cathode keeper are under development at the NASA Glenn Research Center [27].

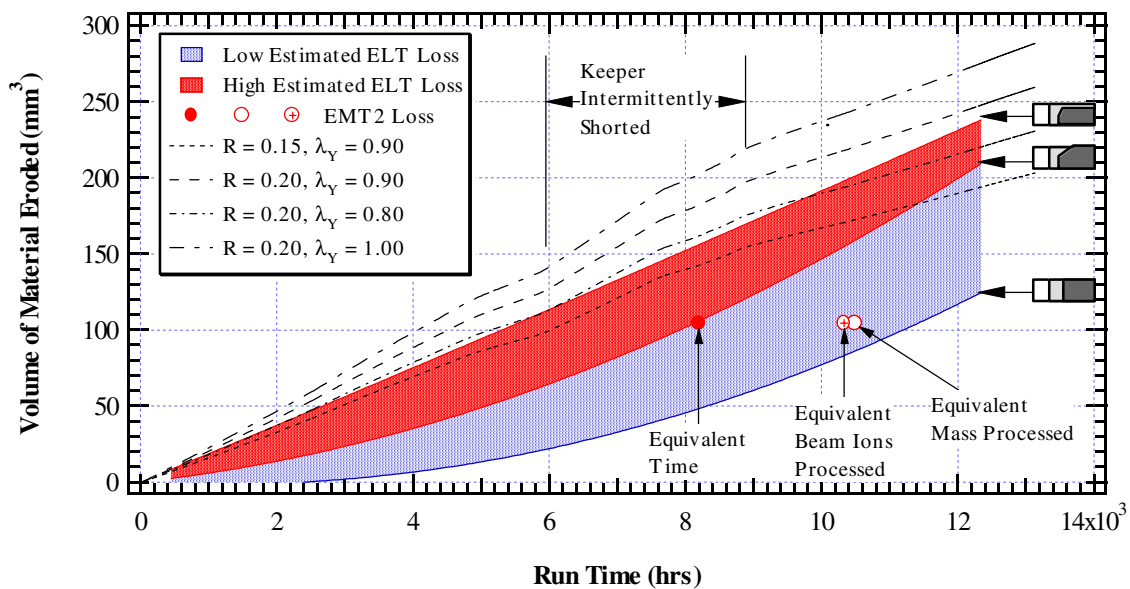
Figure 16 – Observed and calculated eroded volume of the ELT discharge cathode keeper. Only doubly charge ions with negligible temperature and created at a plasma potential 4-V above anode are assumed to sputter the keeper.
